SITE:	Zirco Data
LOCATION:	WELSHPOOL
SCOPE OF WORK:	Fire Protection
COMPLETION DATE:	8th March 2019
CONTRACT VALUE:	\$1.4M

Zirco Data is a Records Management & Document storage facility located at 80-92 Sheffield Road in Welshpool. The facility offers a records management and document storage solution that is intergrated and secure by using inventory tracking, document cataloguing, data capture and online access.

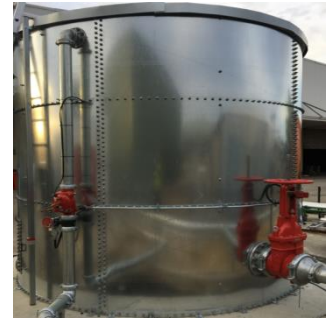
A second Fire Water storage tank with an effective capacity of 25,000 litres was installed to provide enough firefighting water to the new combined systems installed to the building. The tank is complete with an automatic infill from the fire service connection and refills the tank at the required rate of 10l/sec.

The two Fire Water storage tanks have been linked to a common manifold supplying the existing Fire Pumps with the collective capacity and the tank infill satisfying the demand required to meet the new combined systems hydraulically calculated flow and pressure.

- Interconnection of the new tank to the existing tank was complicated due to the existing tank not having an isolation valve connected directly to the suction outlet. The existing tank does not have a drain valve fitted nor is it fitted with a vortex plate. Existing pipework on the suction lines was found to be in a poor state. All items will need to be addressed in the systems maintenance.

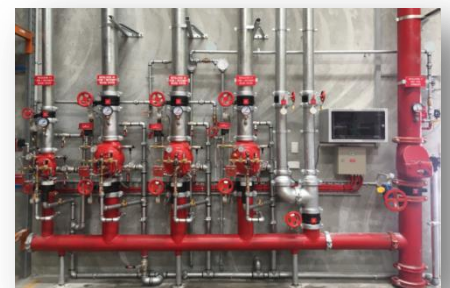
The existing Sprinkler Control Valve located in the Pump House has been relocated to the new common manifold located inside the Warehouse therefore locating all control valves in a common location.

The existing roof level sprinkler system has been adjusted by the change out of the ESFR sprinklers replacing them with 15mm fast response sprinklers rating the system as Ordinary Hazard Group 1. The sprinkler system to the Office area remains unchanged. The sprinkler system will be monitored for low pressure.

- Relocation of the existing Sprinkler Control Valves identified that routine maintenance may not have been carried out compliant to AS1851 with respect of 5 yearly Control Valve overhaul. The face gasket and seat rubber on this existing valve set was replaced eliminating pressure loss through the valve seat. This systems main stop valve is also passing and may require changing out.

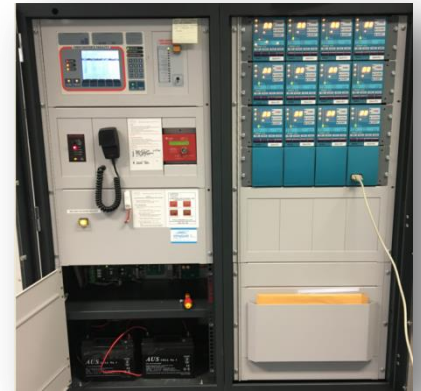
The new Fire Detection works included the expansion and modification of the existing FDCIE Panel to include a cabinet housing the new Aspirating Smoke Detection displays (VESDA) to the same levels and zoning of the Watermist system.

A VESDA panel is located in the field in each zone with all these panels reporting back to the sites existing FIP. New installation works was to also wire the Watermist activation and monitoring from the new control valve locations. Reprogramming of the FIP was required to pick up the new systems and integrate all the existing sites alarms and monitoring.
