<b>PROJECT:</b>	<b>Busselton Shopping Centre – Stage 3</b>
<b>LOCATION:</b>	<b>BUSSELTON WA</b>
<b>SCOPE OF WORK:</b>	Wet Fire Protection
<b>COMPLETION DATE:</b>	September 2023
<b>CONTRACT VALUE:</b>	\$850,000.00

The new extension (Stage 3) of the Busselton Shopping Centre comprises the redevelopment and extension of the existing shopping centre located in the heart of Busselton to accommodate additional key tenants, a cinema and beverage precinct.

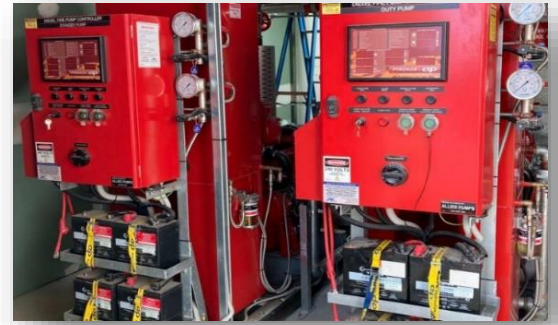
A new fire pump room was provided to house 2 x new dedicated automatic primary and secondary diesel fire pumps complete with a jacking pump for the systems pressure maintenance.

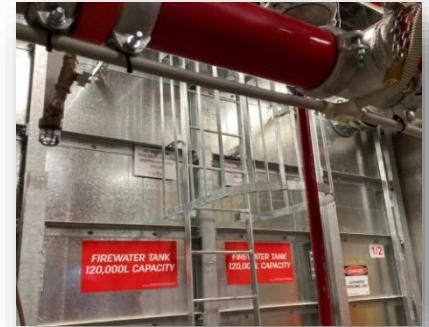
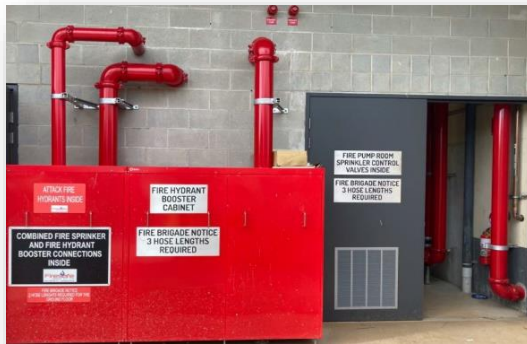
Firesafe provided 2 x 60Lt fire water storage tanks, (120Lt full capacity) with automatic infill fed from the Kent Street town's main to maintain capacity.

We were required to disconnect the existing fire booster cabinet and provide new cabinets to boost the existing and new hydrant system throughout the new and existing complex. A new fire sprinkler booster cabinet was also installed adjacent to the fire pump room to booster the fire sprinkler installations No's. 1-4.
