PROJECT:	Wearne Aged Care Redevelopment
LOCATION:	Cottesloe WA
SCOPE OF WORK:	Wet Fire Protection
COMPLETION DATE:	December 2021
CONTRACT VALUE:	\$1M

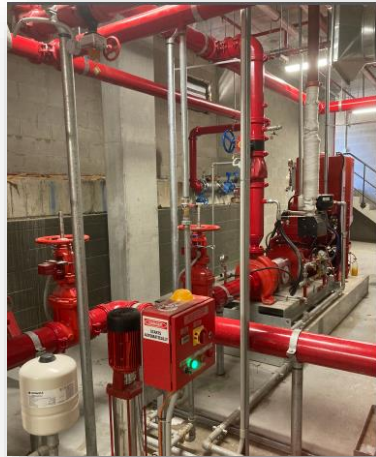
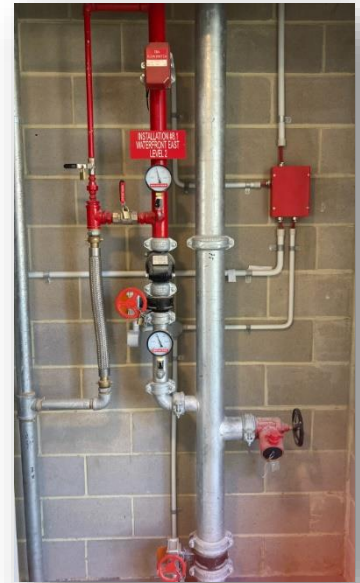
Fire Pumps consisting of 1 diesel duty booster pump and 1 diesel standby pump have been installed to supply the combined fire sprinkler, fire hydrant and hose reel system.

Sprinkler Control Valve assemblies have been installed in the Fire Pump Room located on the Ground Floor of the Marine Views complex and also on Level 1-4, South Stair 2, Ground & Level 1 West Stairs 6 plus Levels 2-5 East Hydrant & Sprinkler Control Valve cupboard in the Waterfront East Cottesloe complex.

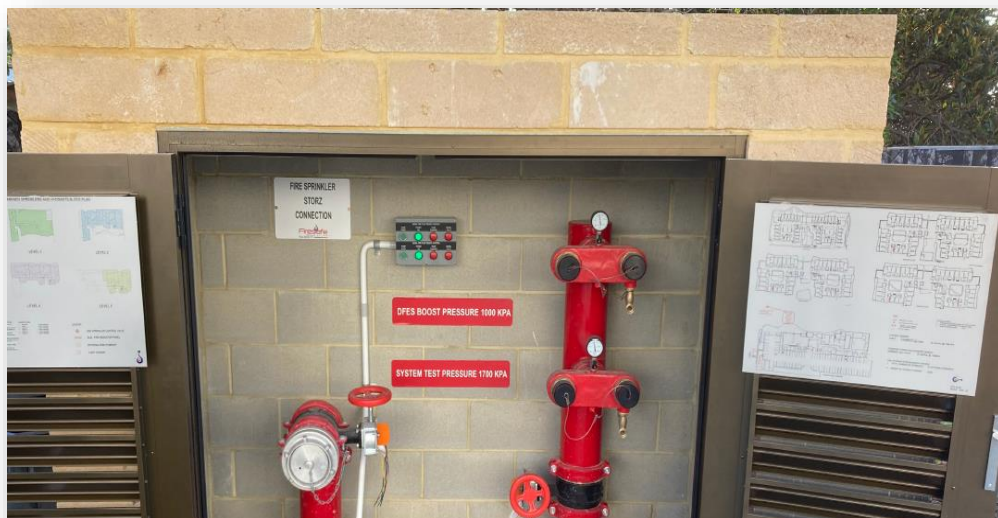
Hydrants have been installed in the Fire Stairs, Carpark and Hydrant Cupboards. There are also hydrants installed in the BOH areas of Marine Views. Feed hydrants have been installed in the Fire Services Booster Cabinet off the main entrance to Marine Views from Warton Street adjacent to the turning area.

The Fire Brigade booster connection is a storz connection service which provides the Brigade with a connection to draw water from the onsite water storage tanks in order to facilitate the boosting of the system should they require to do so.
