PROJECT:	Glassford Warehouse
LOCATION:	KEWDALE WA
SCOPE OF WORK:	Wet/Dry Fire Protection
COMPLETION DATE:	April 2022
CONTRACT VALUE:	\$750,000.00

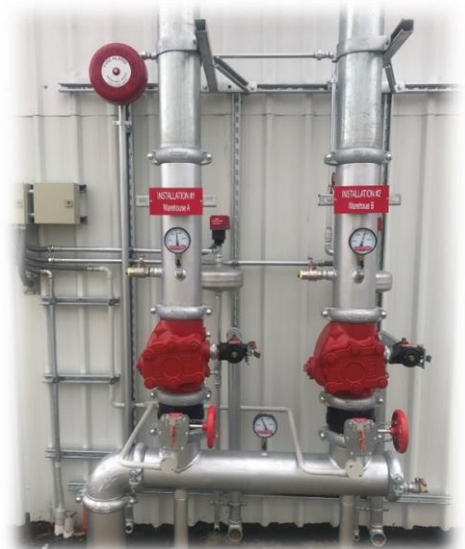
Fire sprinkler control valves have been installed externally at the rear of the warehouse.

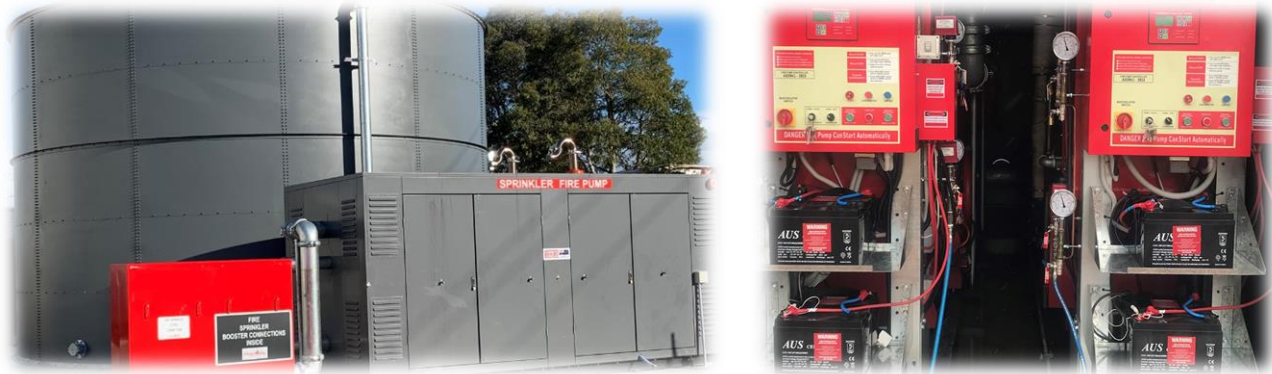
The water supply for the project is provided by 1 x 100% (350kL) capacity water storage tank, with no infill. Top up water for the tanks is from the sites hydrant system. A 100mm quick fill line has been provided for fast filling of the tank. Top up water for the tank is from the site hydrant system.

The fire pump set installed consists of a primary diesel and standby diesel pump complete with a jacking pump and are housed within a containerised enclosure.

The pumps and tank are located in the North-Western corner of the site.
