COMPLETED PROJECTS

SITE:	Aldi Distribution Centre
LOCATION:	Jandakot WA
SCOPE OF WORK:	Fire Protection – (Fire Sprinkler / Fire Detection)
COMPLETION DATE:	March 2016
VALUE:	\$3M

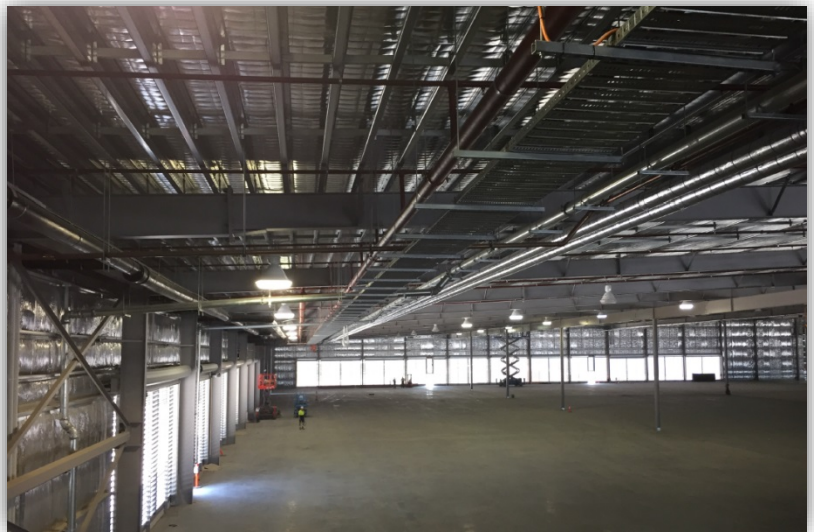
- Secondly, the steel structure had been rationalised to minimise steel weight, towards light weight construction, this meant that the free space between the structural frameworks was constantly changing and not aligned.
- The design works had to be coordinated with the project managers and structural steel designers / engineers and/or construction team, as the steel was installed so the was the fire pipe allowing for immediate change of site coordinated pipe runs.
