| <b>PROJECT:</b> | <b>East Metro Health – RPH (A Block)</b> |
| <b>SCOPE OF WORK:</b> | Wet/Dry Fire Protection |

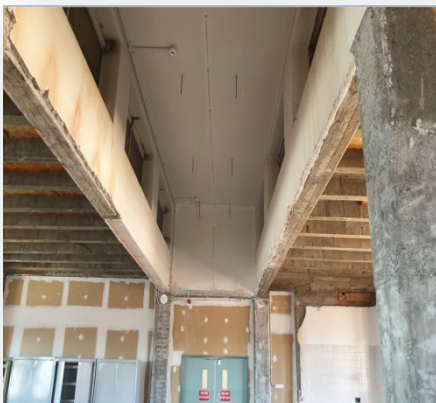
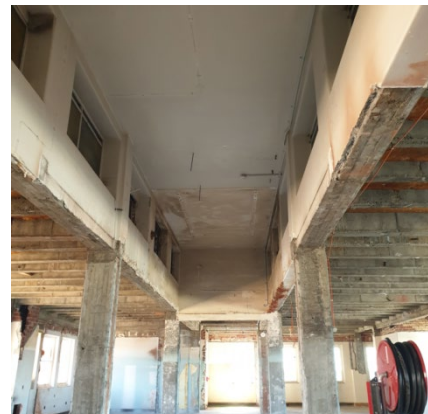
The existing fire sprinkler system was modified to allow for the installation of the new ceilings throughout the building.

The sprinkler system is charged from a water supply coming from the Water Corporation town's main connected to the existing fire Pumps. The Control Valves are located on Levels 1, 2, 11, 12 and 13

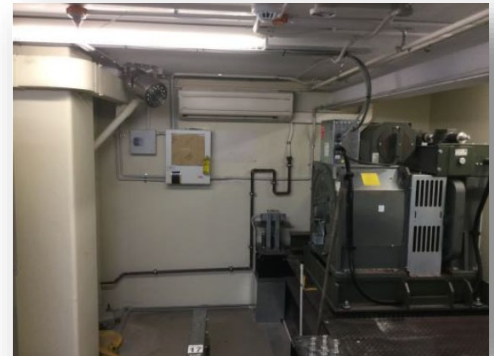
The Stat-X Dry Powder Fire Extinguishing system is installed to cover the Lift Motor Rooms located on Levels 11 (3 rooms), 12 (3 rooms) and 13 (1 room) which are wired back to the FIP module on Level 12. The canisters for the system are located within a purpose built enclosure around the Lift Motor and Switch Rooms.
